## FIELD SAFETY NOTICE

**Commercial name of the affected product:** REANIBEX 300 y REANIBEX 500

**FSCA-Identifier:** RECALL 0118 R300-500

**Type of action:** FSCA Field Safety Corrective Action

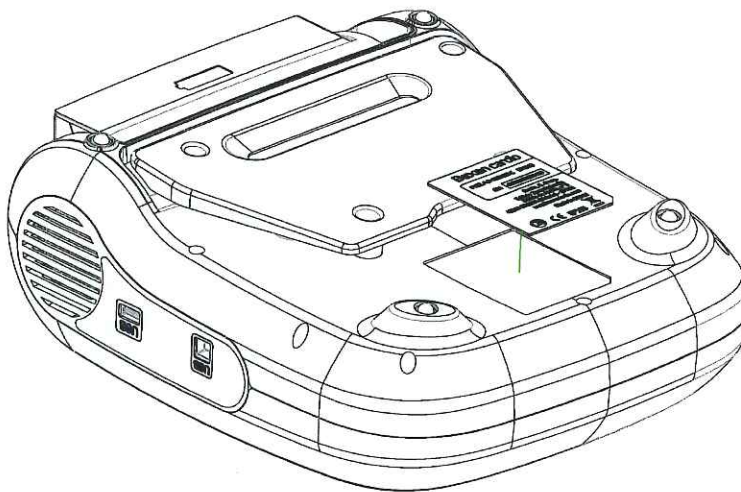
The Serial Number is found on the label indicated on the drawing and is indicated by the symbol "SN"
