URGENT FIELD SAFETY NOTICE

Product Name: **Alaris™ GS, GH, CC, TIVA, PK, Enteral Syringe Pump**

Product Name: **Asena™ GS, GH, CC, TIVA, PK Syringe Pumps**

FSCA Identifier: **RA-2017-02-02**

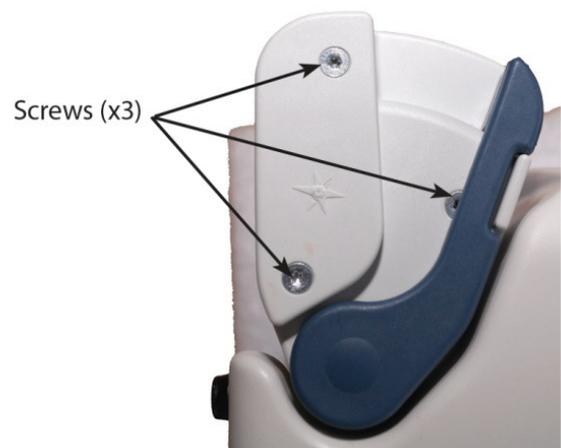
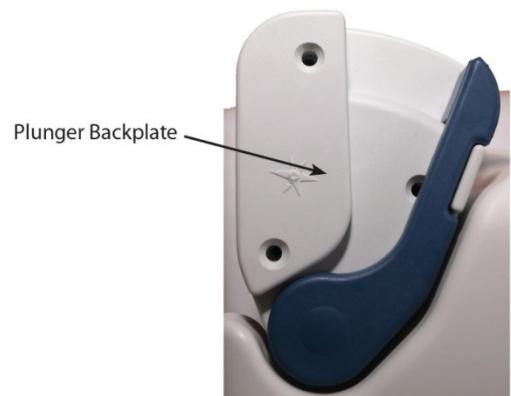
1. Remove three screws holding plunger backplate.
2. Remove the plunger backplate.
Note: Be cautious when removing as parts may become loose. Placing the Pump in a vertical orientation may assist with maintaining components in place.
3. Visually inspect the interior of the plunger, replace any broken components.
See Technical Service Manual *Chapter 6 Corrective Maintenance* for further details.

Recommended during every Preventative Maintenance and at the minimum every three years that the plunger backplate spring is replaced.

A kit of 10 replacement springs is available, part number 1000SP01589.

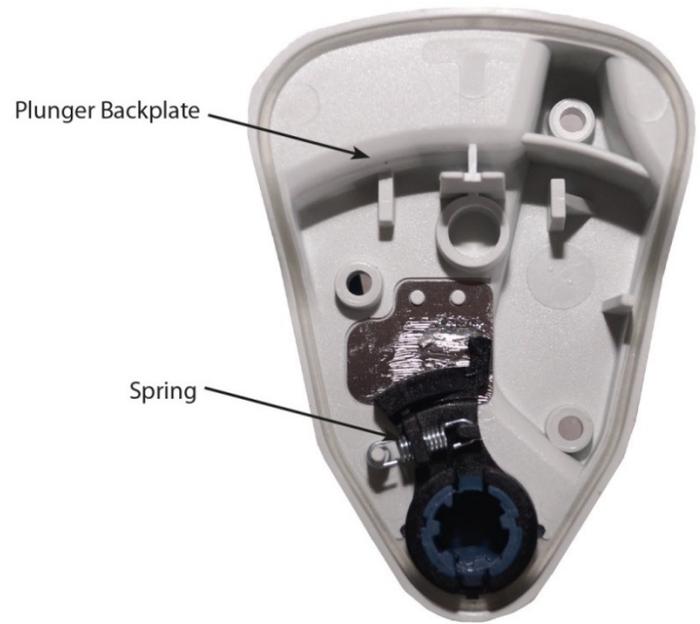
4. Remove the spring from the plunger backplate.
5. Fit a new spring to the plunger backplate.
6. Refit the plunger backplate.
7. Fit the three screws into the plunger backplate.
